VERKHOF EHF

Heli verks: Gilsbakkí-Gilhagi - Sumarhús Óxarfirði		Númera: Svavar M. Sigurjónsson 19067.3419 Björgvin O. Sigurjónsson 110481.9279	Dags: 25.02.2022
Helti teikningar: Aðal- og brunavarnaruppdráttur Útlit Sníð og afstöðumynd		Samþykkt: <i>Þórunn M. Sig.</i>	Geymslunúmer: 101 Verknúmer: 21-58 Málkyrta: 1:50/2000
Hannað: SMS: ...	Teiknað: ... / SMS	Mál: HM	Yfirfarið: BÓS
			Teikn nr.: 102

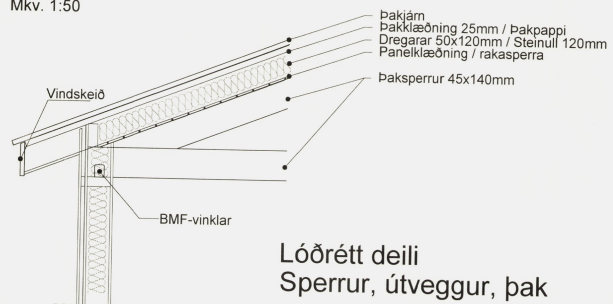
Lóðrétt deili
Sperrur, útveggur, þak

Lárétt deili
Útveggir, horn

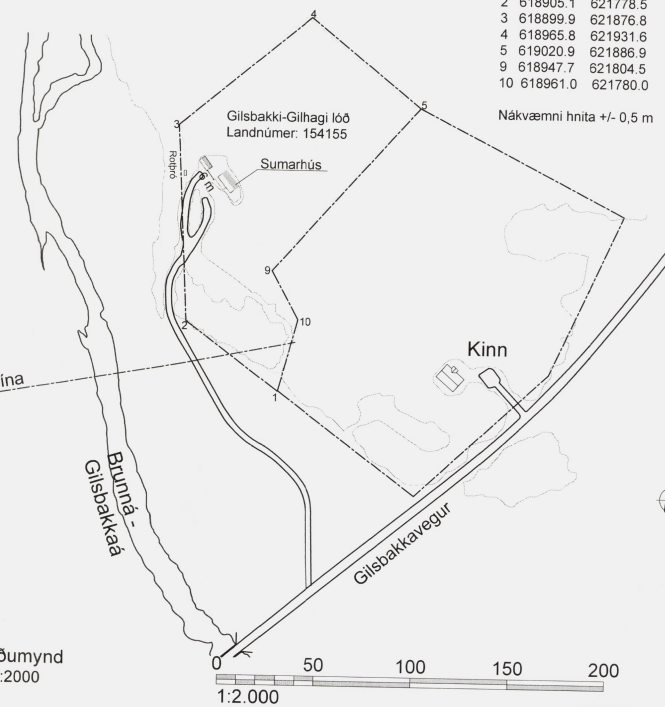
Hnitaskrá f. mörk lóðar í ISNS

Nr	X=Austur	Y=Norður
1	618951.4	621744.1
2	618905.1	621778.5
3	618899.9	621876.8
4	618965.8	621931.6
5	619020.9	621886.9
9	618947.7	621804.5
10	618961.0	621780.0

Nákvæmni hnita +/- 0,5 m
